Using Sonar for Navigation - Part Two

By Steve Dashew

Marina Coral

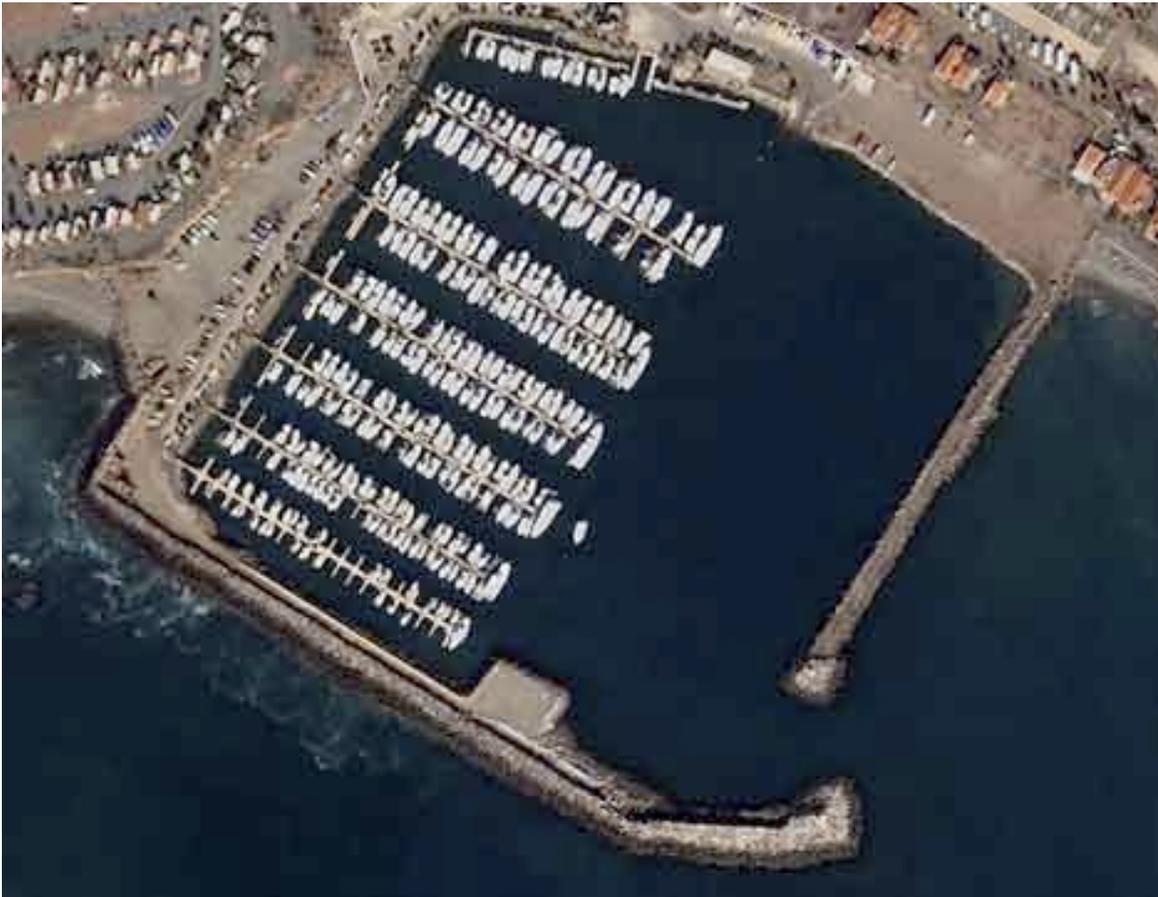
There is no indication of this new harbor on the charts, but we picked up the image above at Google Earth so at least we had a feel for the harbor arrangement. The marina office had assured us the entrance was wide and deep, and at half tide we would have "no problem" with our five foot (1.5m) draft. As we rarely rely on local "knowledge" in the absence of SONAR we would have launched the dinghy to sound out the entrance.

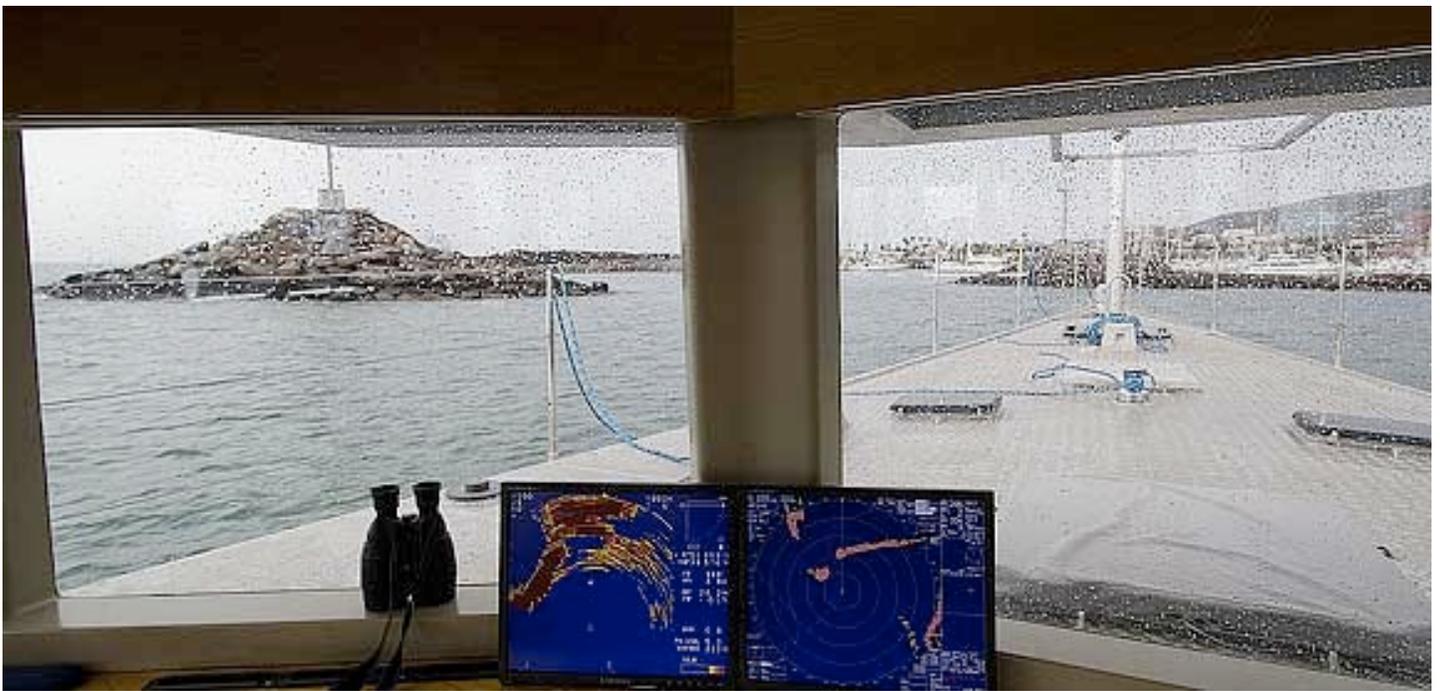
Here is the view from the bridge of *Wind Horse*, our 83 foot (25.4m) motor yacht. The images from the Furuno CH270 SONAR and 2117 RADAR are at the bottom of the photo. This will begin to give you an idea of just how narrow an entrance this is.

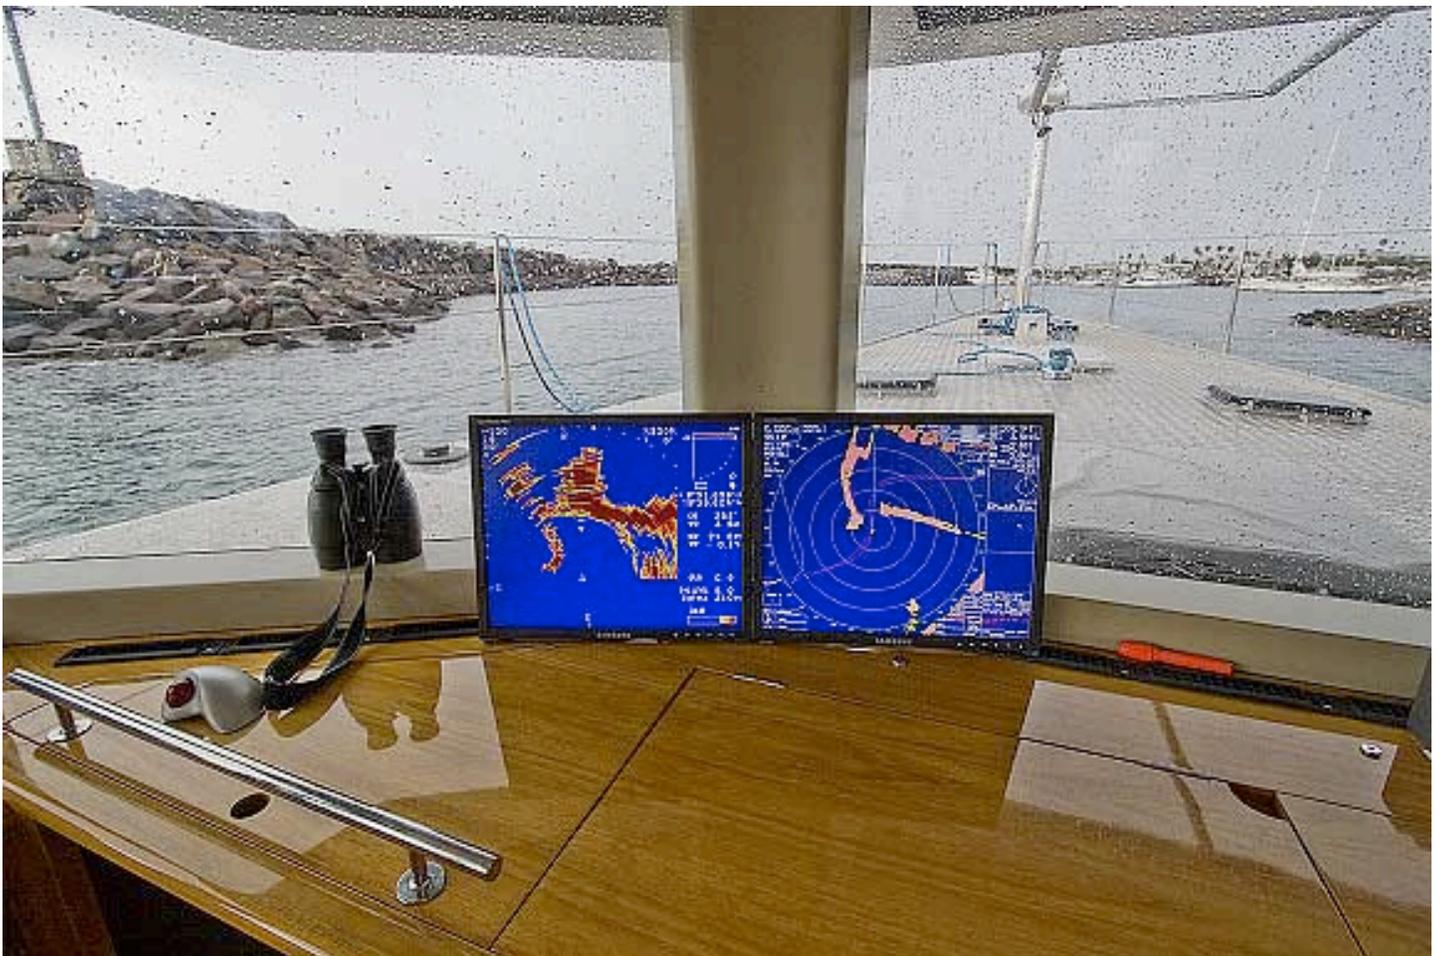
The RADAR is set to minimum scale, 1/8th of a nautical mile, and each range ring represents 150 feet (45m). The SONAR is on a scale of 300 feet (90m) forward.

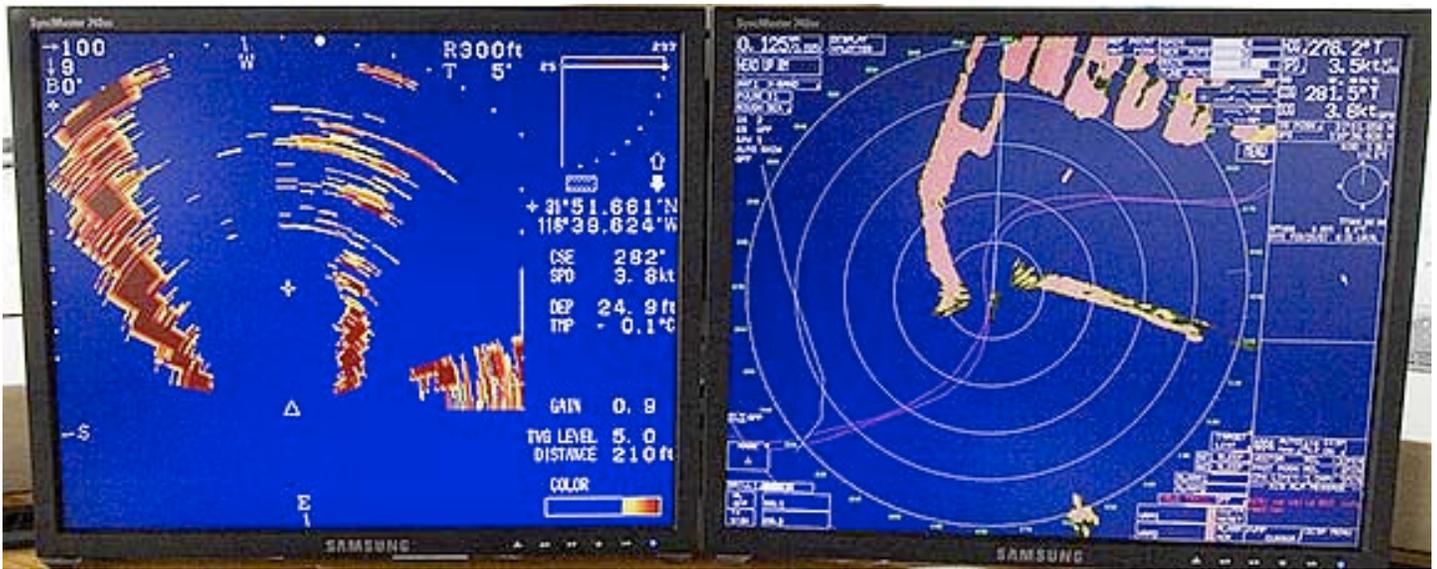
In this close up of the two screens you can get a real feel for how the SONAR (on the left) works. We easily confirm the breakwater edges and that there is plenty of water on each side and ahead directly ahead of us.

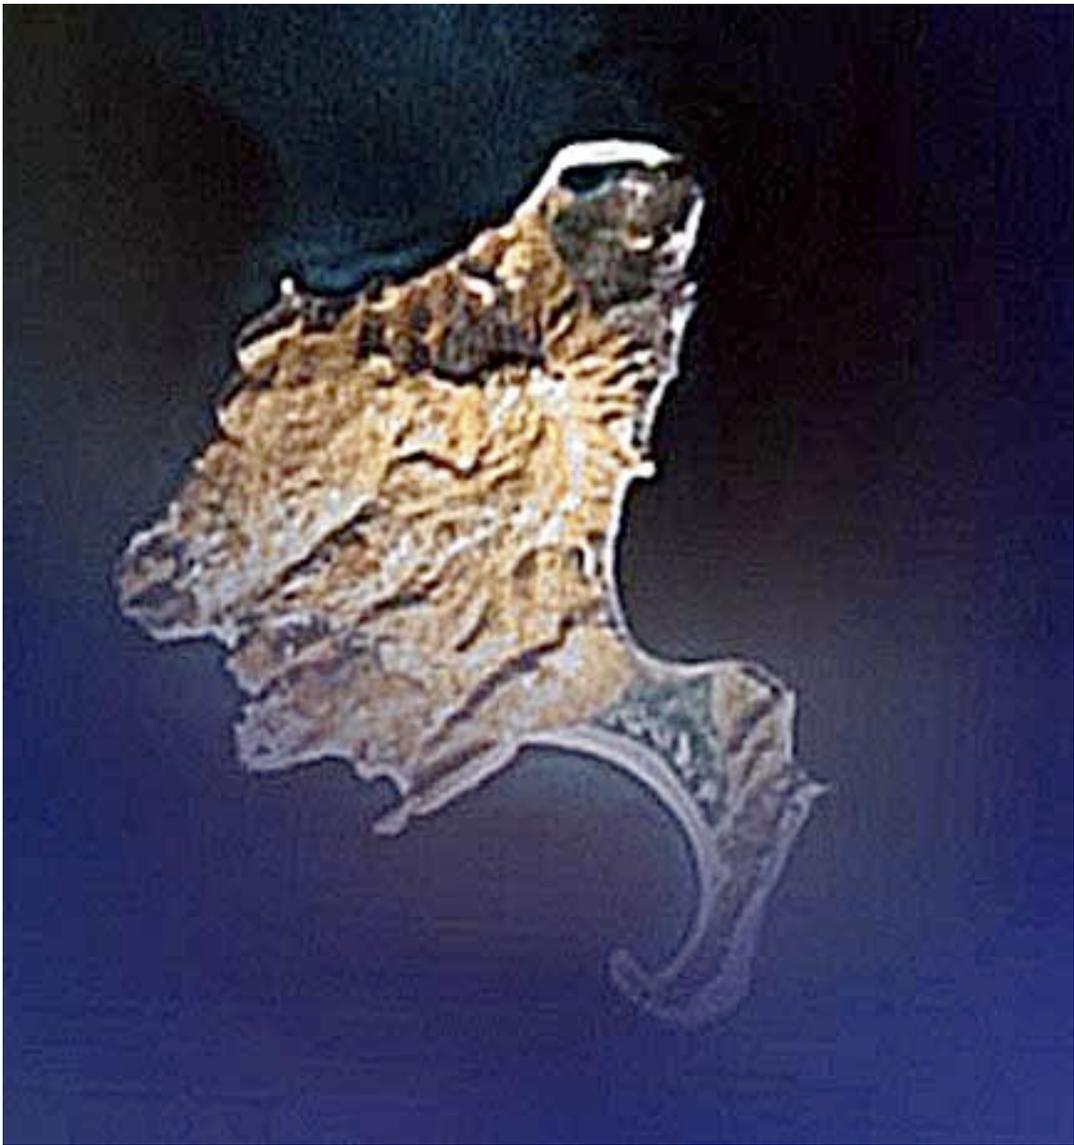
Isla San Francisco in the Sea of Cortez is a lovely spot to hang out when the weather is settled. The Google image (above) shows us a bit more than the paper and electronic charts. The overall shape is there, but of course without soundings.

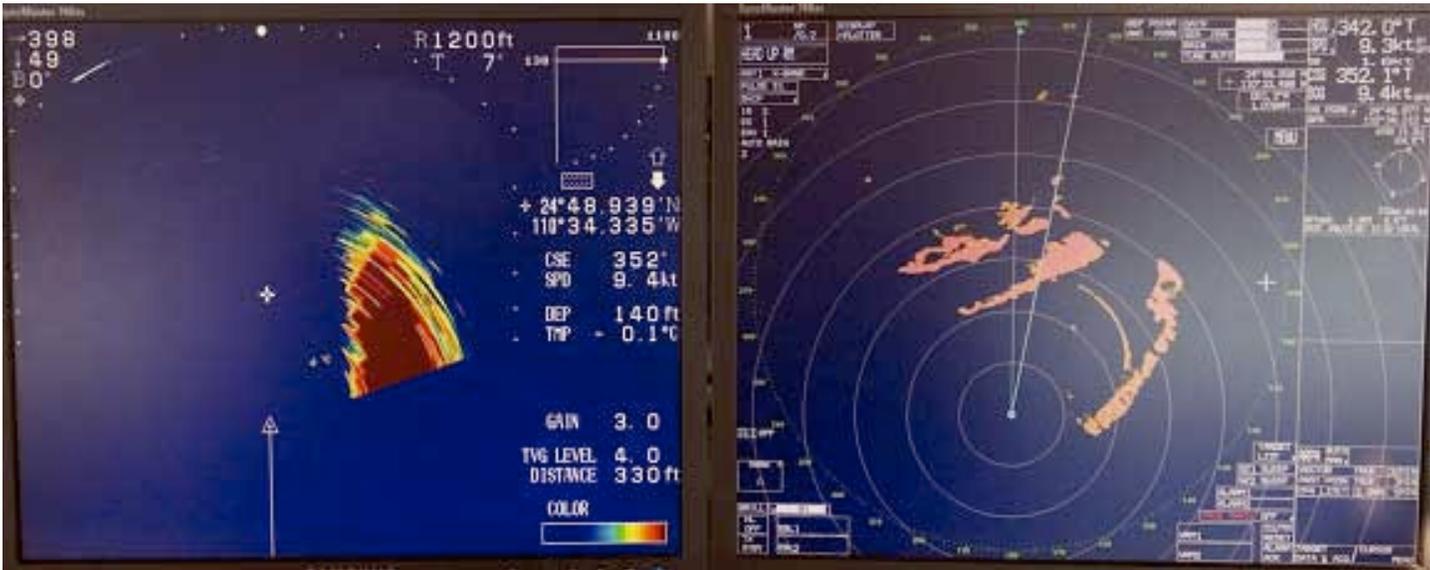
Putting the SONAR to work, here we are closing with the anchorage from the south. The SONAR (image above and left) is showing a clear path ahead, but there is something near the surface off our starboard bow (the dense red image). The RADAR screen on the right will put this into perspective. If you refer back to the Google image, you can see the hooked reef which is attached to the southern end of the island. That is giving us the SONAR return. Notice that this reef *does not show up* on radar as it is below the surface at high tide and it is also missing from the chart.

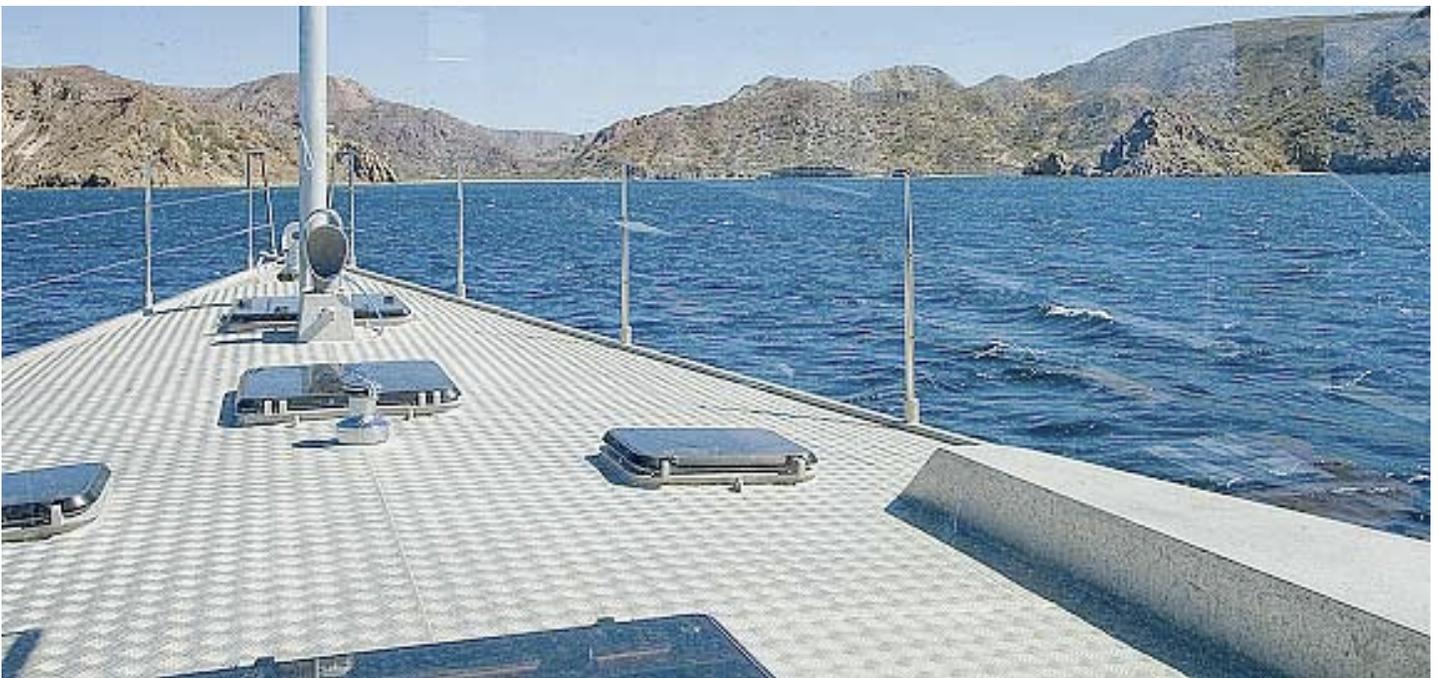
One more example from a little further north in the Sea of Cortez, this time Ballandra Bay on Isla Carmen, across from the town of Loreto. The photo above is looking right into the entrance of the anchorage. We know from previous visits that the entrance is deep in the center, but that there are reefs projecting out from the edges.

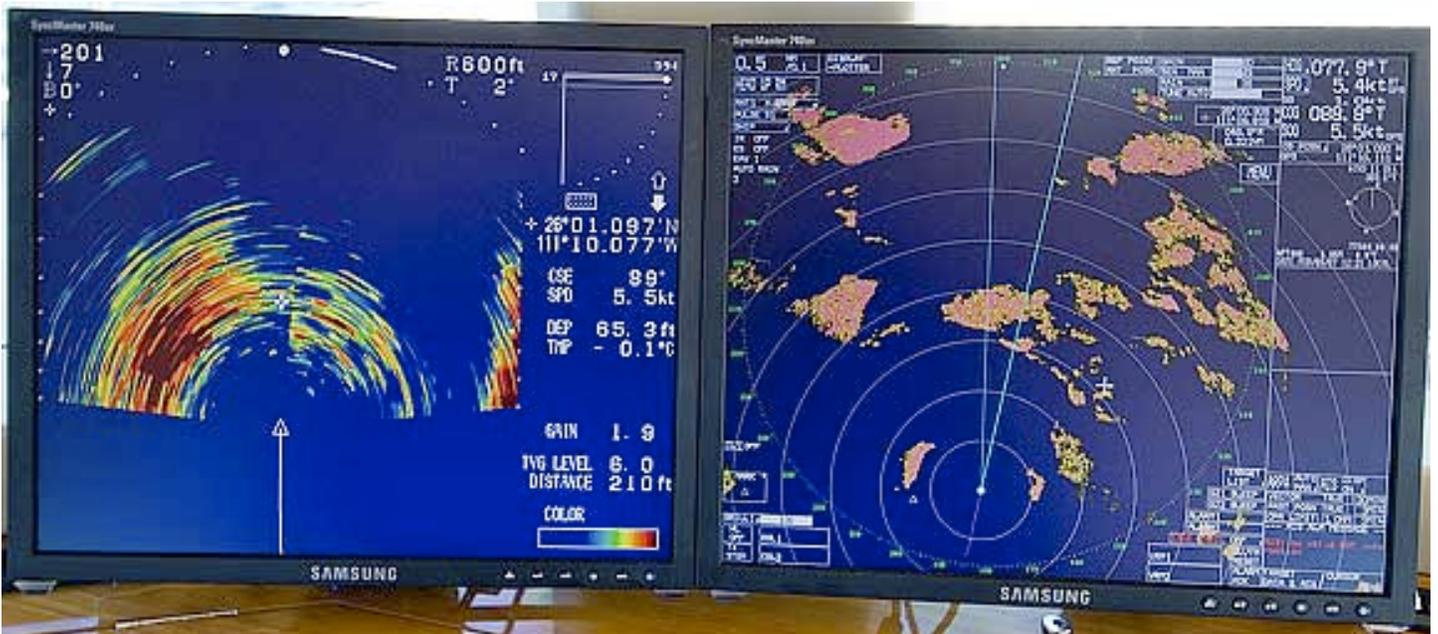
The SONAR here is on a 600 foot (180m) range while the RADAR is on half mile range, with each range ring equal to roughly 600 feet (180m). We are between the headlands which form the entrance to Ballandra Bay. You can see the reef on both sides of the SONAR image, much closer to us than the land mass indicated by RADAR.
